NPDES Compliance Evaluation Inspection (CEI) Report

Name and Location of Facility Inspected Certified Alloy Products, Inc. (CI - 6734) 3245 Cherry Avenue P.O. Box 90 Long Beach, CA 90801		Entry Date 9/20/2010 Entry Time 11:30 AM	Permit Effective Date 6/25/2010
NPDES Permit Number CAG994003	Order Number R4-2009-0047	<input type="checkbox"/> Major <input checked="" type="checkbox"/> Minor	Permit Expiration Date 4/30/2014
Name(s) & Title(s) of On-Site Representative(s) Ralph Druyor (EHS Manager) Joseph Huang (V.P. of Manufacturing)	Contact Information Phone: (562) 595-6621 ext. 227 Fax: (562) 989-0143 E-mail: rdruyor@doncasters.com	Notified of Inspection? <input checked="" type="checkbox"/> Yes <input type="checkbox"/> No	
Name, Title & Address of Responsible Official Joseph Huang (V.P. of Manufacturing) 3245 Cherry Avenue, P.O. Box 90 Long Beach, CA 90801	Contact Information Phone: (562) 595-6621 ext. 224 Fax: (562) 595-0143 E-mail: jhuang@doncasters.com	Official Contacted? <input checked="" type="checkbox"/> Yes <input type="checkbox"/> No

Certified Alloy Products, Inc. (NPDES No. CAG994003) Photo Log
Inspected by: Jared Richardson (PG Environmental, LLC)

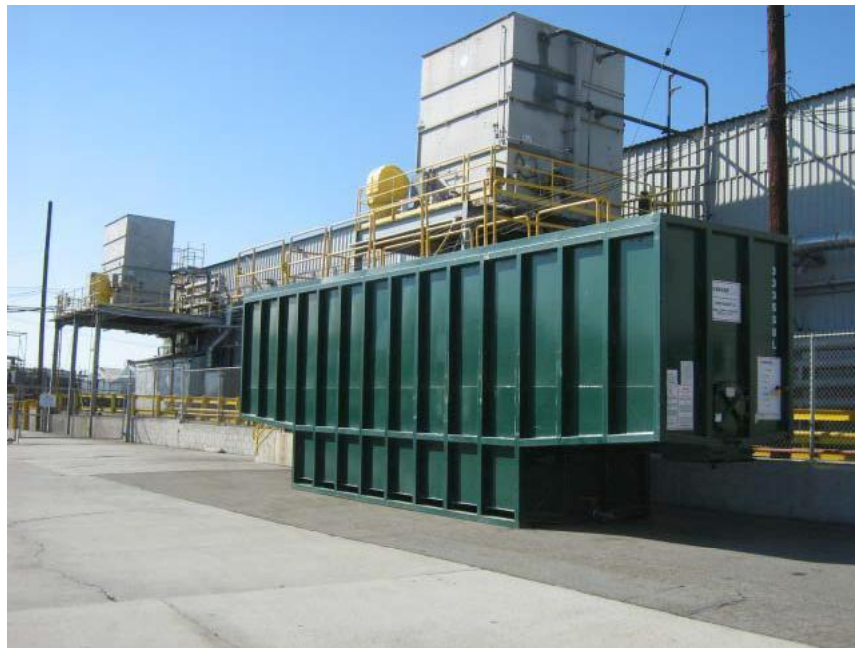
Photo 2: Portable 20,000 gallon Baker Tank utilized by the Facility as an interim storage for NCCW.

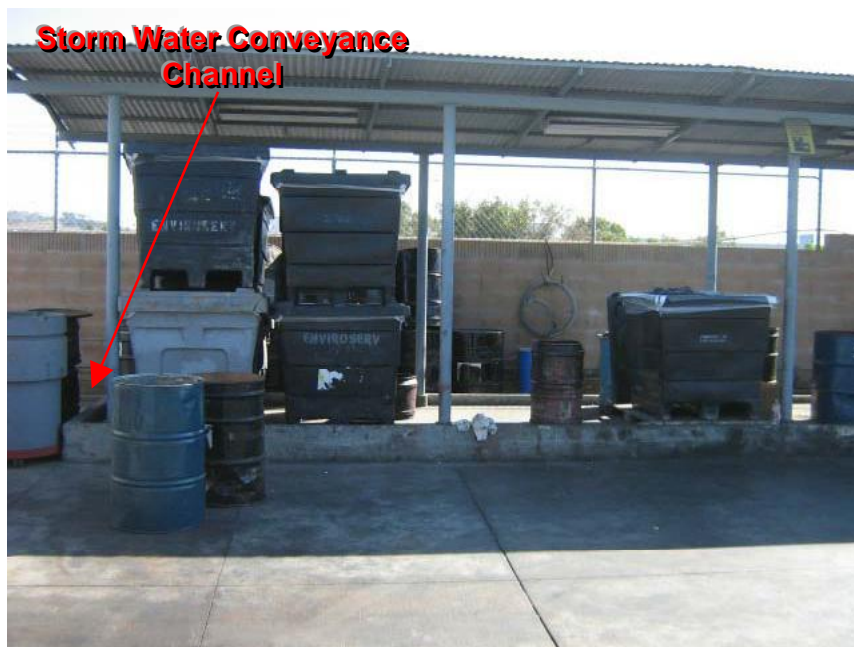
area (refer to Photo 3) located at the southwest corner of the Facility. Specifically, an open drain was noted in the secondary containment berm was observed in the open position (refer to Photos 4 and 5). As a result, there was a potential for the contribution of pollutants to storm water runoff from the hazardous waste storage area and subsequent discharge to the adjacent storm water conveyance channel (refer to Photos 3 and 5). The conveyance channel runs along the southern portion of the Facility and discharges to the local MS4 (as stated by the Facility representative) and ultimately into the Los Cerritos Channel. An observation of the discharge point did not indicate any evidence of pollutants. It should be noted that the hazardous waste storage area was actively being utilized at the time of the inspection. The storage of used oil, aerosols, oily rags, etc. was also observed (refer to Photo 6).

Photo 3: View of Facility's hazardous waste storage area. A storm water conveyance channel is located adjacent to the concrete wall behind the hazardous waste storage area.

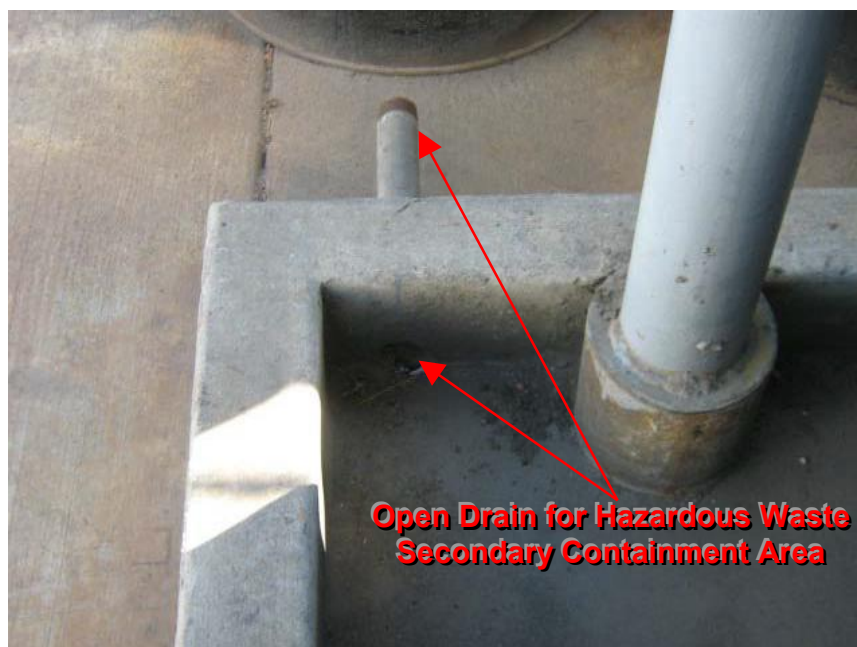
Photo 4: View of open drain for the hazardous waste secondary containment area at the Facility.

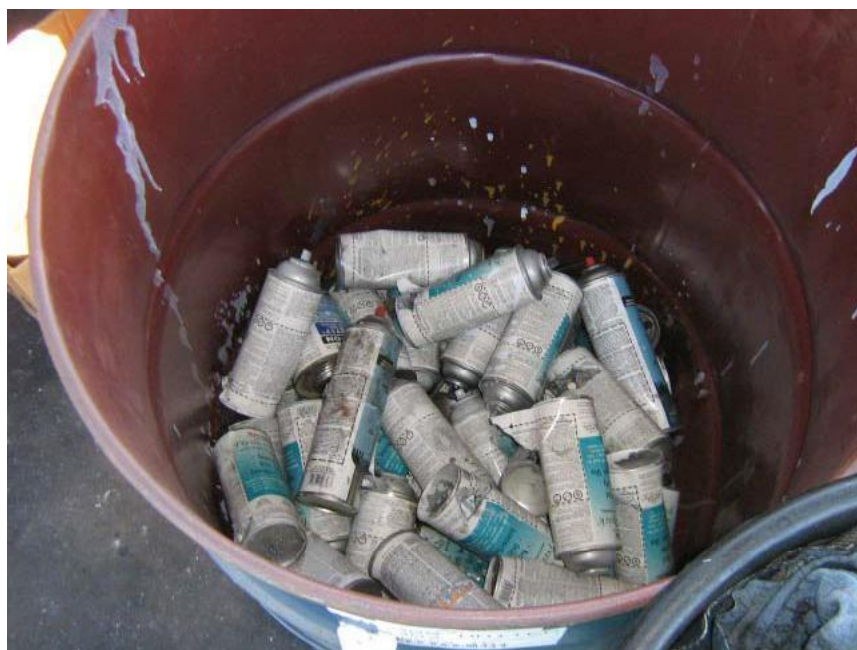
Photo 6: View of used aerosol cans stored in the hazardous waste storage area.

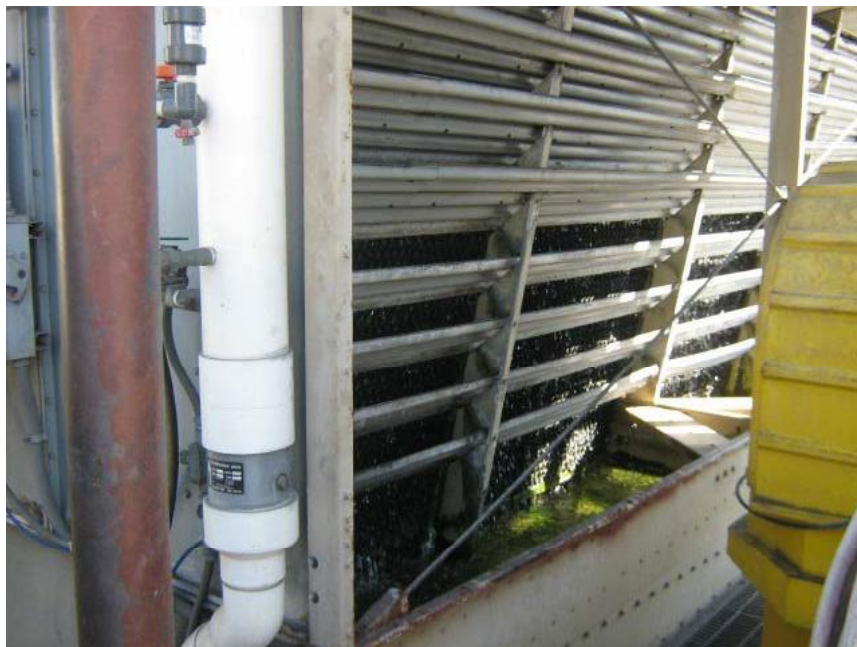
Photo 7: View of non-contact cooling water effluent at the Z-F cooling tower.

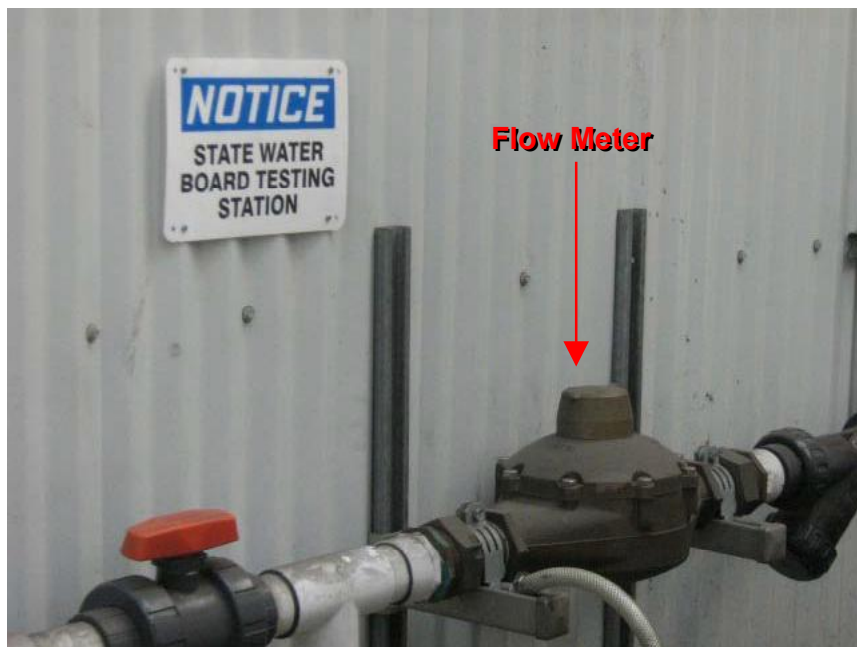
Photo 8: View of flow totalizer meter connected to the sanitary sewer discharge location. Note that the Facility was not actively discharging to the sanitary sewer at the time of the inspection; however, the Discharger had prepared the connection in preparation of receiving approval on the Sewer Use Permit.

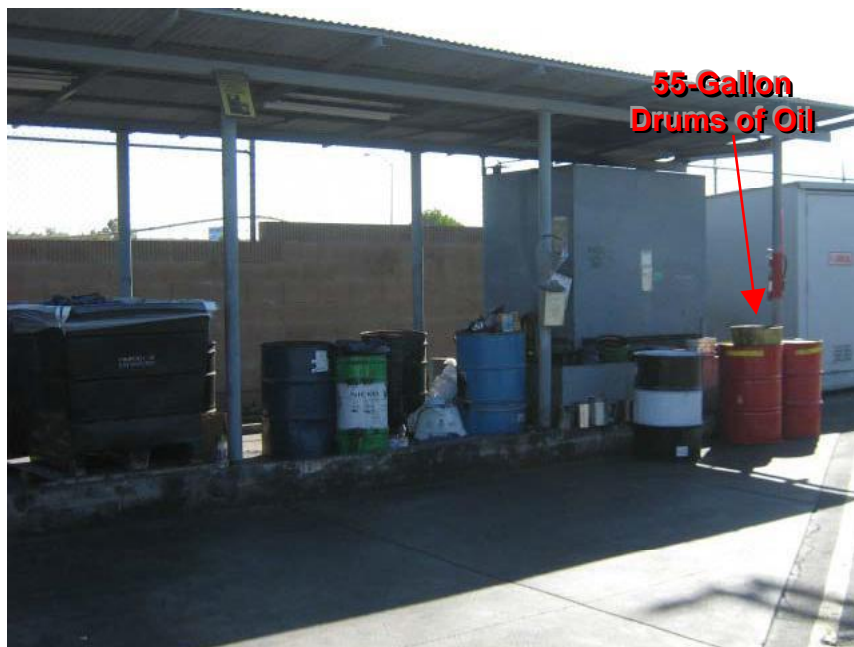
Photo 9: View Facility's hazardous waste storage area. Note the two partially full 55-gallon drums of oil stored outside of secondary containment without bungs in place.

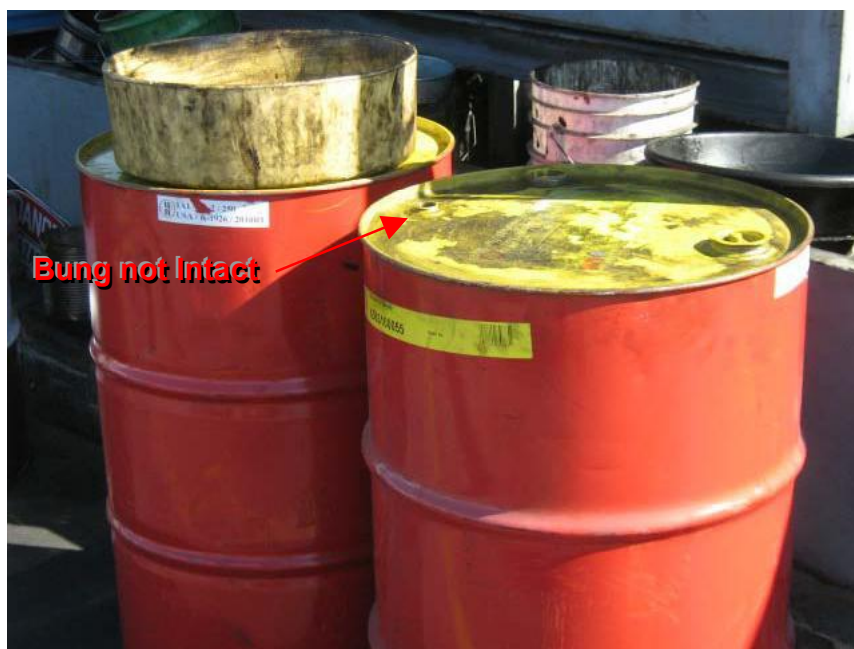
Photo 10: Close-up view of the uncovered and uncontained 55-gallon drums of oil. Note that the bungs were not in place for either of the 55-gallon drums of oil.

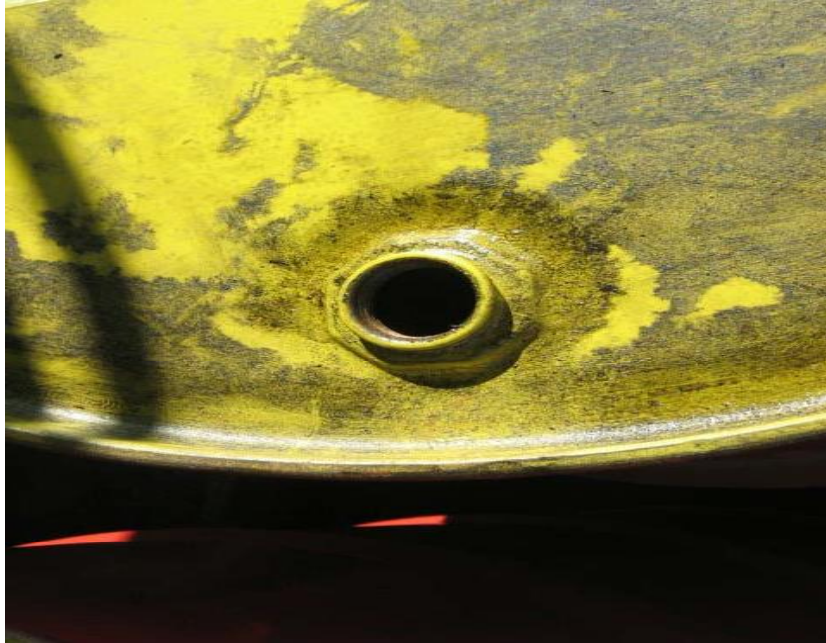
Photo 11: Close-up view of bung not in place for one of the two 55-gallon drums of oil shown in Photos 9 and 10 above.

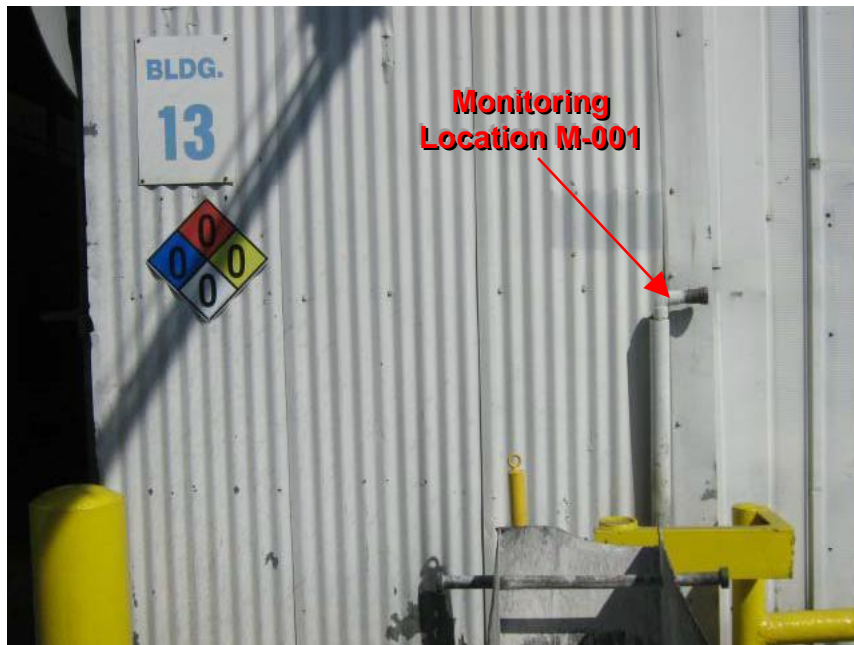
Effluent samples for Discharge Point 1 are collected as grab samples from a sample port (Monitoring Location M-001) (refer to Photo 12), prior to contact with the receiving water and/or dilution by any other water or waste (e.g., storm water), at the southeast corner of the Facility adjacent to Cherry Avenue, which subsequently flows into the Los Cerritos Channel. The sample collection location and methods appeared to provide representative samples.

Photo 12: Monitoring Location M-001. Note that the monitoring location and sample port has been disconnected.

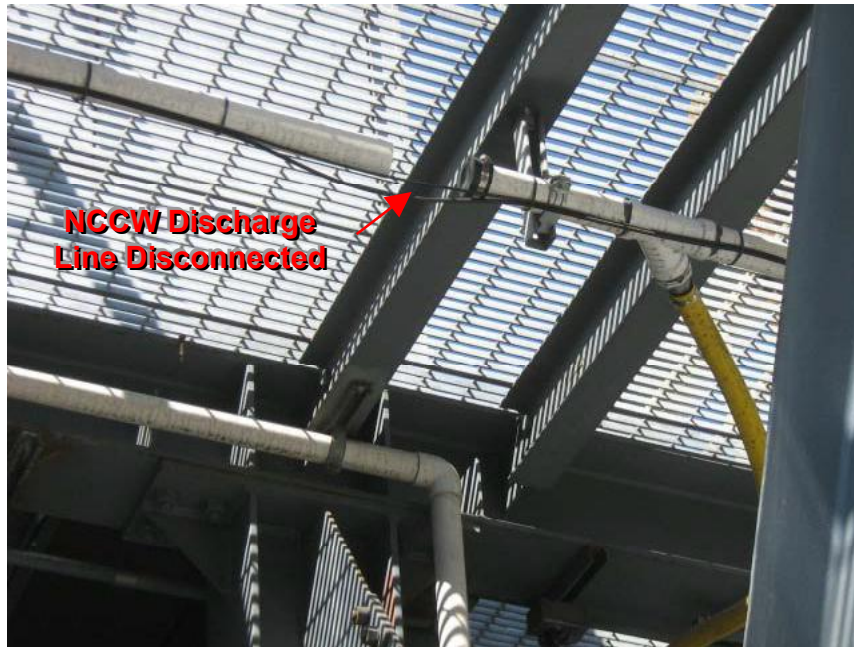
Photo 13: Note that the NCCW discharge line has been disconnected.
